### **Air Monitoring Summary Tables**

### Period H<sub>2</sub>S Monitoring Hydrogen Sulfide Offsite Monitors

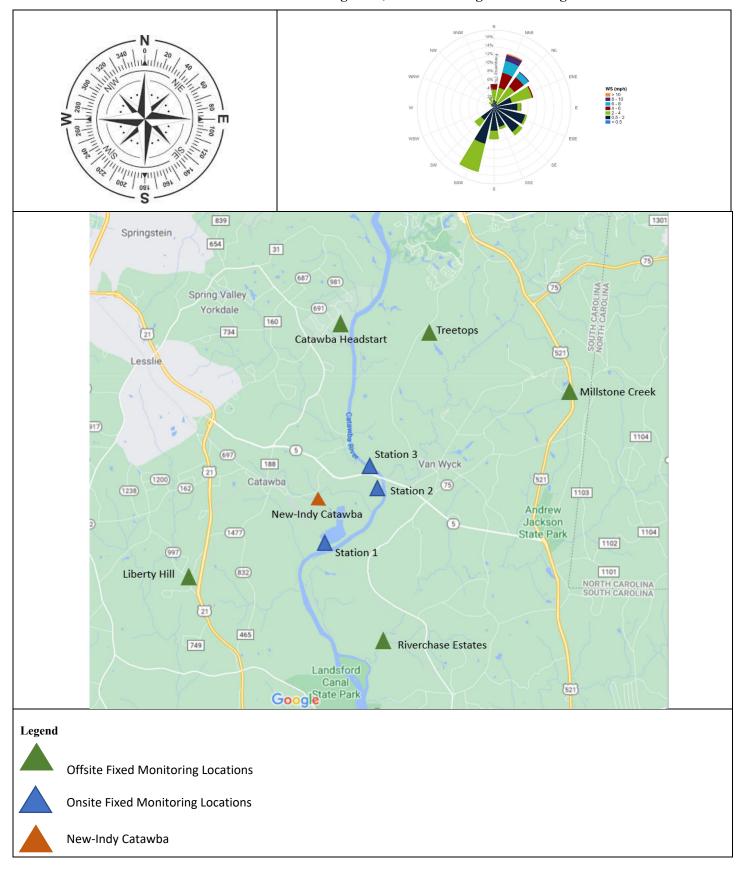
Wind rose – Shows the direction the wind is coming from, the monitoring station being at the center of the rose.

See wind rose diagram with aerial map figure for full wind data during this reporting period.

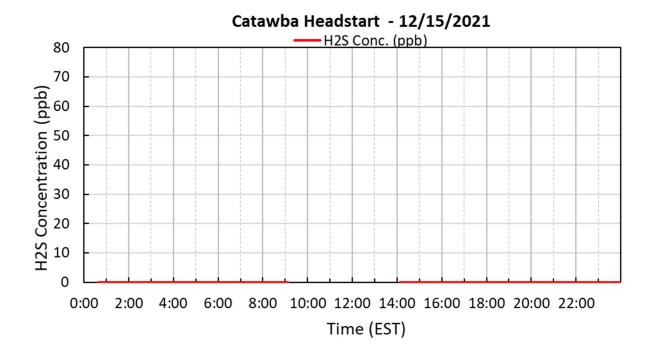
Below are graphs for offsite locations where hydrogen sulfide (H<sub>2</sub>S) was detected during the current reporting period.

The five stand-alone H<sub>2</sub>S monitoring stations correlate with five previous EPA's Viper monitoring system which includes areas to the north-northeast and south-southwest of the New-Indy Catawba Mill.

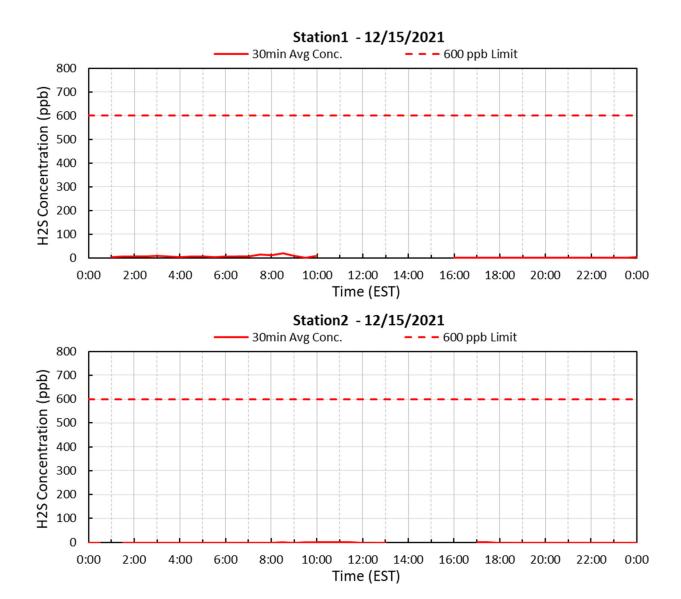
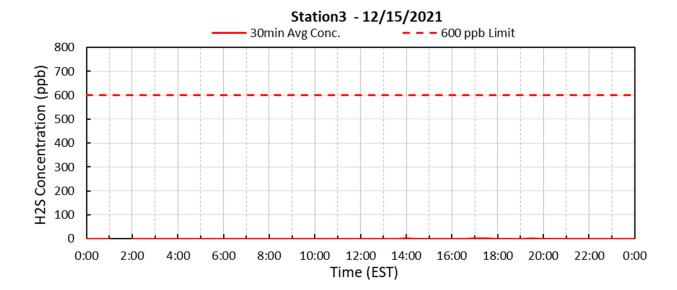
Below are graphs for onsite locations during the current reporting period.

Depending on wind direction, the H<sub>2</sub>S measured at the onsite fence line locations may not exit mill property at reported concentrations. Wind directions from offsite locations, blowing onto mill property, will disperse ambient concentrations to lower levels prior to exiting the plant site.

<sup>&</sup>lt;sup>g</sup> Quarterly performance audit at Station 1 from 10:30 to 13:00 EST. Station 1's old converter was swapped out for a brand new one at 12/15/2021 13:30. A multipoint verification was performed from 14:00 to 15:30 EST. The 24-hr average at this location is not represented by the full 24-hr period; a total of 11 30-minute averages are missing from the reported period.

<sup>&</sup>lt;sup>h</sup> Quarterly performance audit at Station 2 from 13:30 to 16:30 EST. The 24-hr average at this location is not represented by the full 24-hr period; a total of 7 30-minute averages are missing from the reported period.
