Air Monitoring Summary Tables

From: 2/1/22 12:00 am To: 2/1/22 11:59 pm

Period H₂S Monitoring Hydrogen Sulfide Offsite Monitors

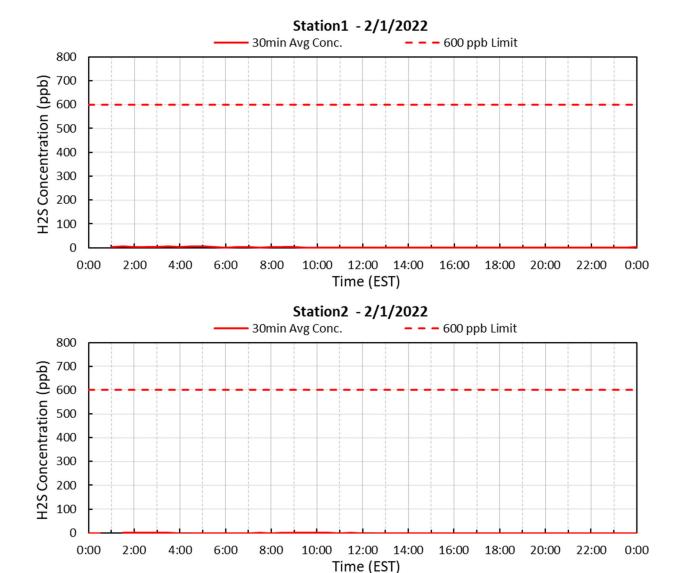
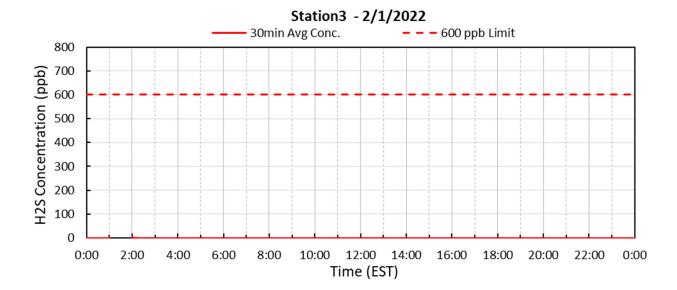
Below are graphs for onsite locations during the current reporting period.

Depending on wind direction, the H₂S measured at the onsite fence line locations may not exit mill property at reported concentrations. Wind directions from offsite locations, blowing onto mill property, will disperse ambient concentrations to lower levels prior to exiting the plant site.
