### **Air Monitoring Summary Tables**

From: 3/14/22 12:00 am To: 3/14/22 11:59 pm

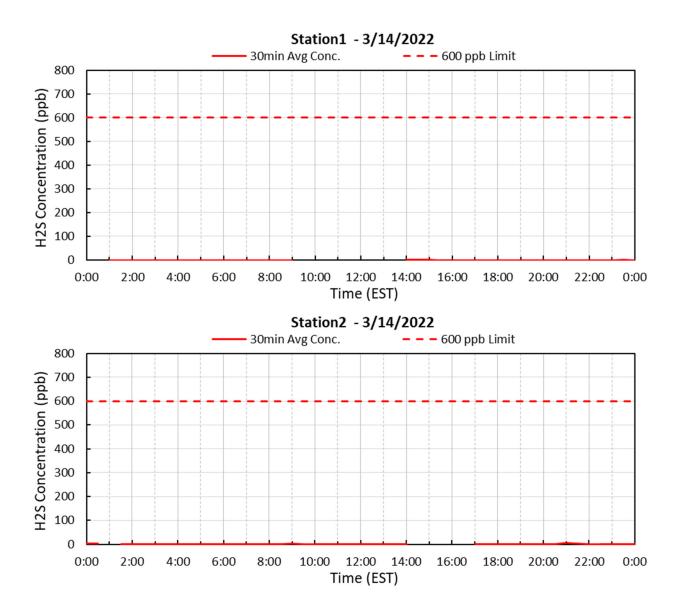
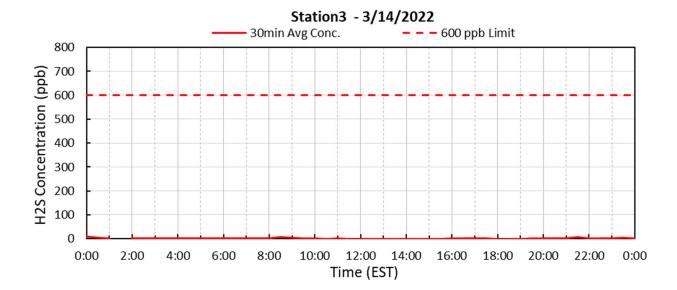
Below are graphs for onsite locations during the current reporting period.

Depending on wind direction, the H<sub>2</sub>S measured at the onsite fence line locations may not exit mill property at reported concentrations. Wind directions from offsite locations, blowing onto mill property, will disperse ambient concentrations to lower levels prior to exiting the plant site.
