# Air Monitoring Summary Tables

## Offsite Monitors

## Period H<sub>2</sub>S Monitoring Hydrogen Sulfide Offsite Monitors

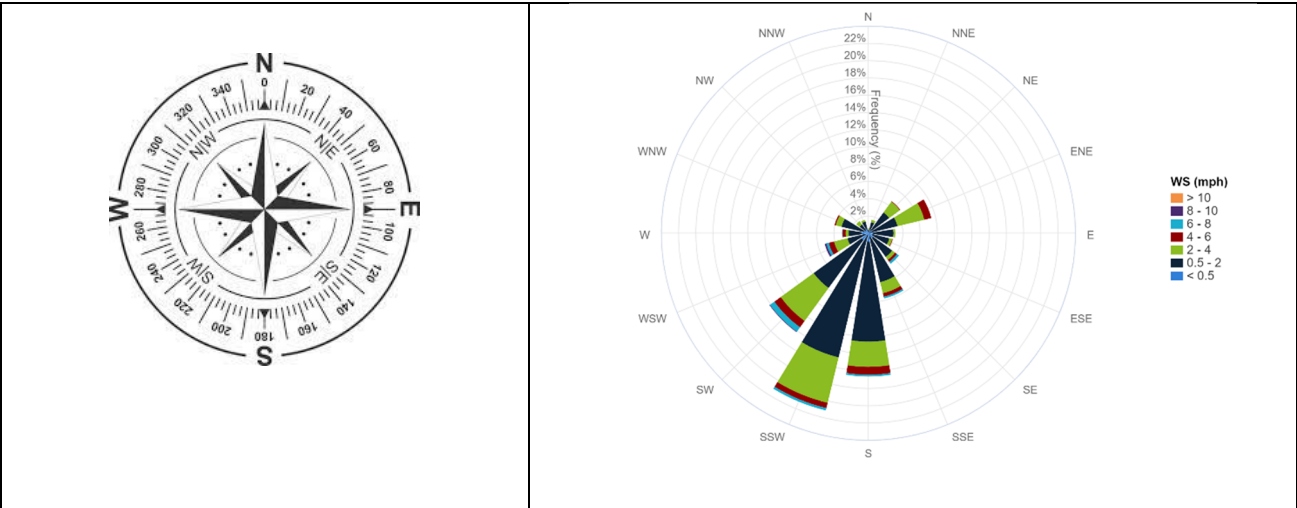
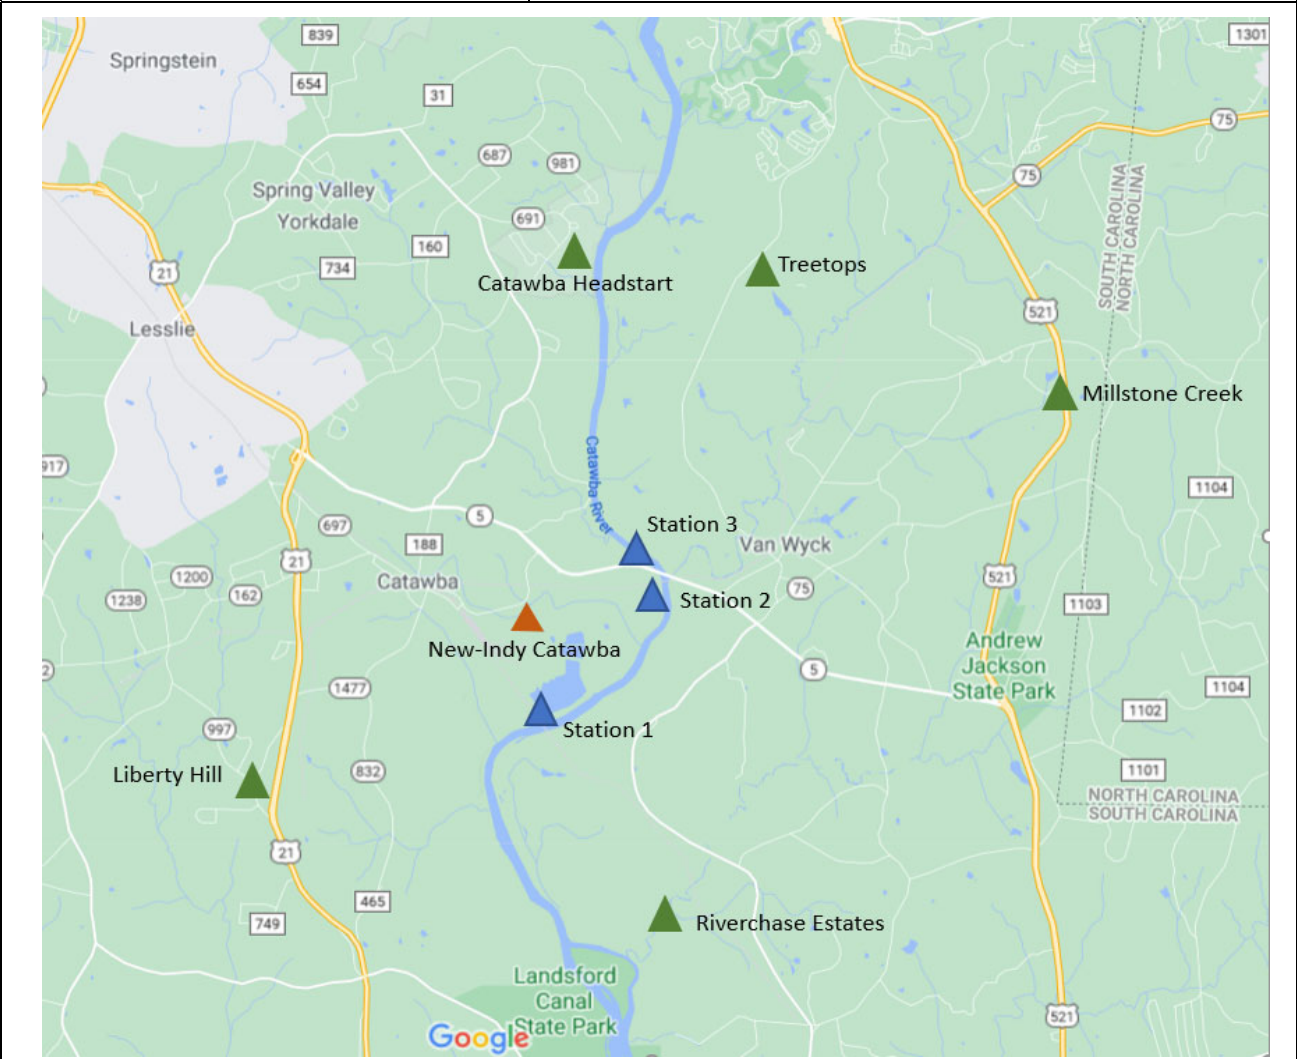
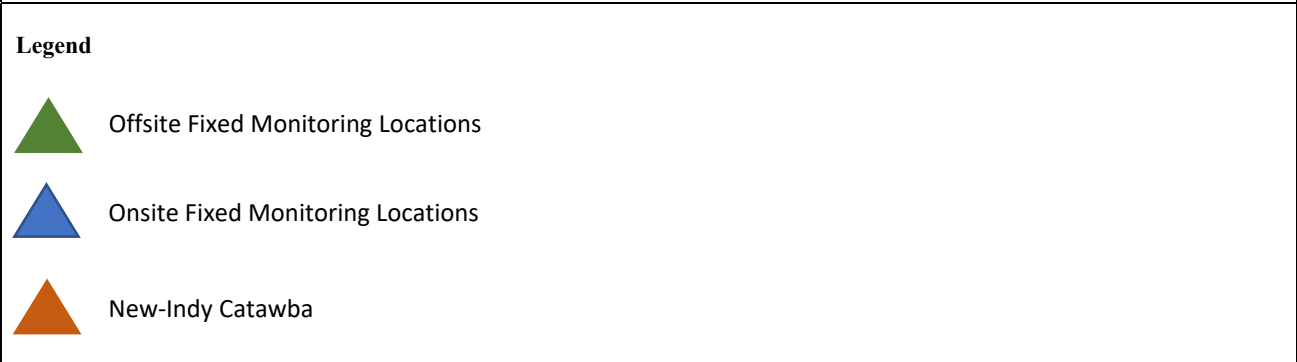
Wind rose – Shows the direction the wind is coming from, the monitoring station being at the center of the rose.

See wind rose diagram with aerial map figure for full wind data during this reporting period.

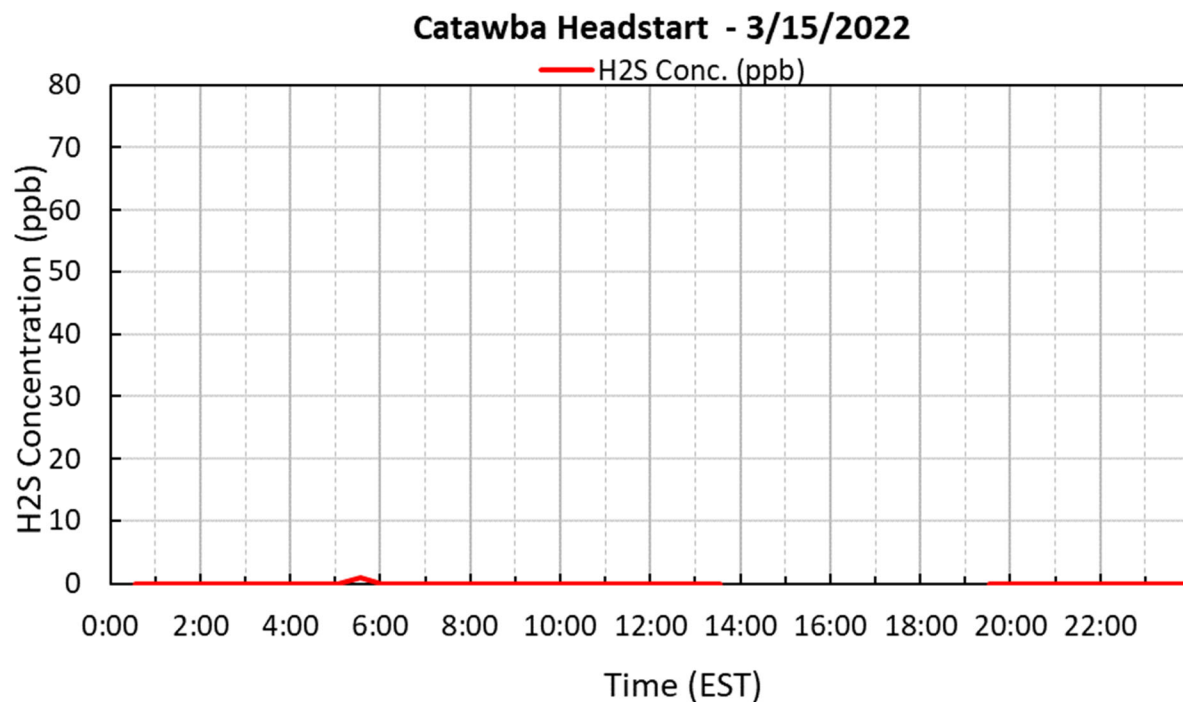
Below are graphs for offsite locations where hydrogen sulfide (H<sub>2</sub>S) was detected during the current reporting period.

The five stand-alone H<sub>2</sub>S monitoring stations correlate with five previous EPA's Viper monitoring system which includes areas to the north-northeast and south-southwest of the New-Indy Catawba Mill.

Winds came from the south - southwest at 1 to 4 miles per hour.

<sup>b</sup> Quarterly performance audit at Catawba from 14:00 to 19:00 EST. The 24-hr average at this location is not represented by the full 24-hr period; a total of 11 30-minute averages are missing from the reported period.

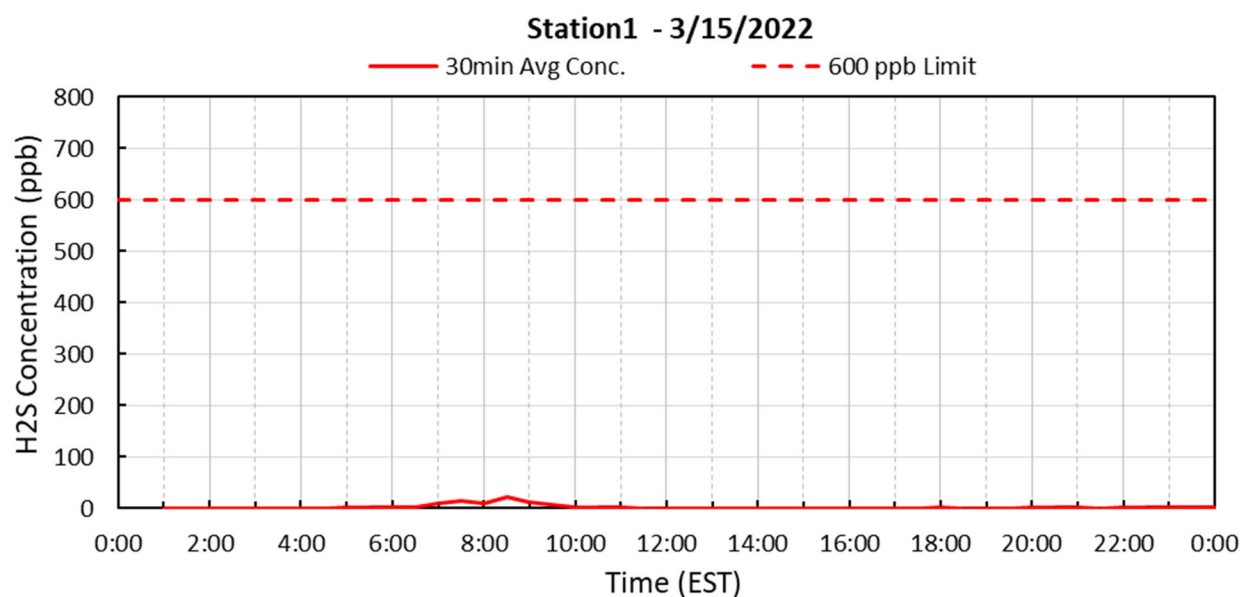
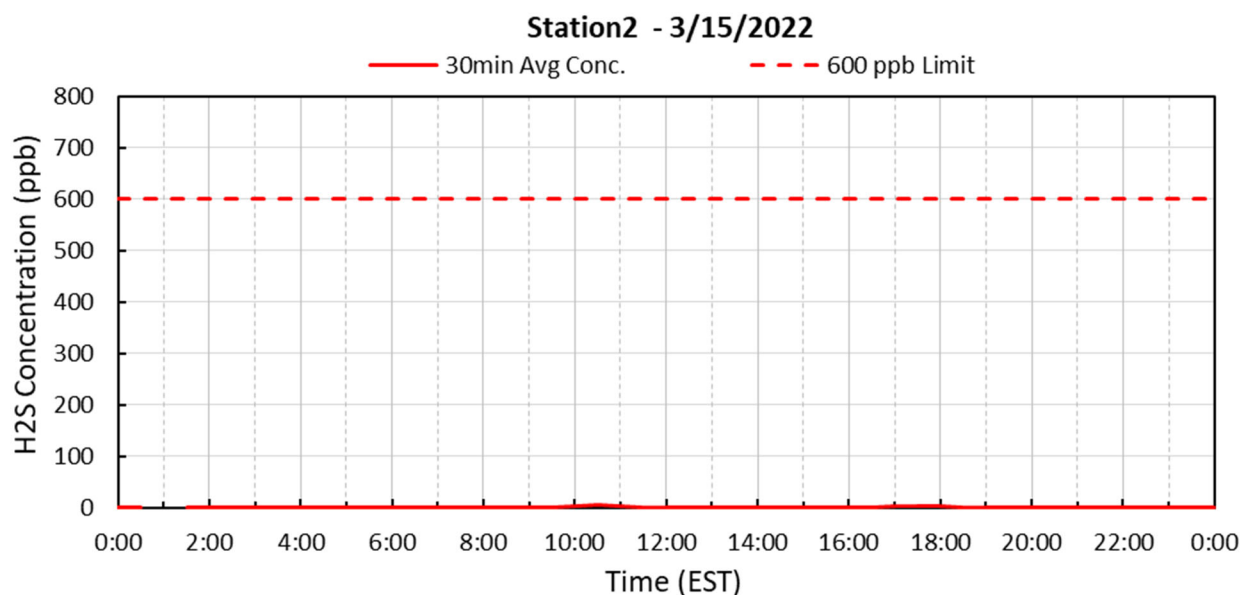
Below are graphs for onsite locations during the current reporting period.

Depending on wind direction, the H<sub>2</sub>S measured at the onsite fence line locations may not exit mill property at reported concentrations. Wind directions from offsite locations, blowing onto mill property, will disperse ambient concentrations to lower levels prior to exiting the plant site.

Winds came from the south - southwest at 1 to 4 miles per hour.
