Air Monitoring Summary Tables

New-Indy Catawba

Period H₂S Monitoring Hydrogen Sulfide Offsite Monitors

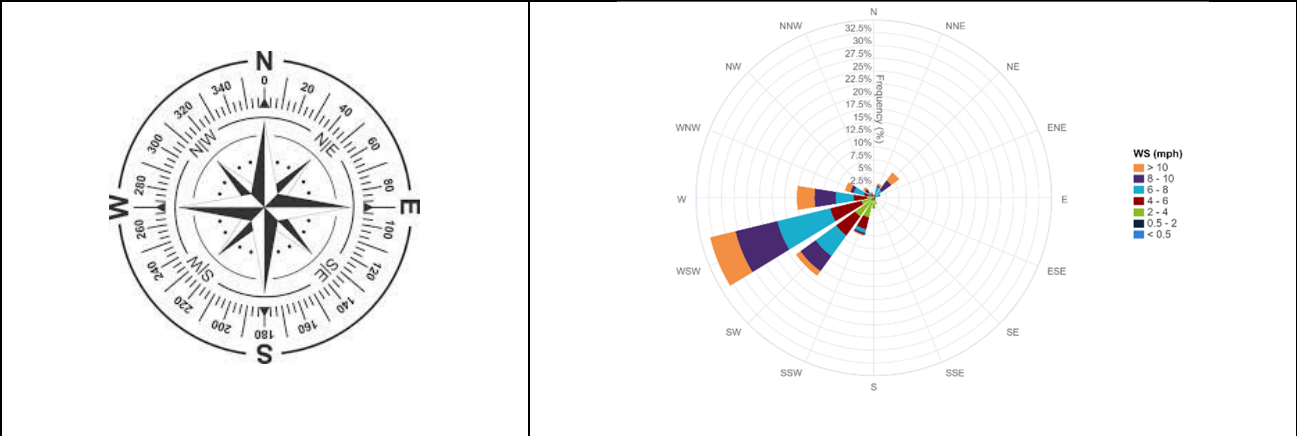
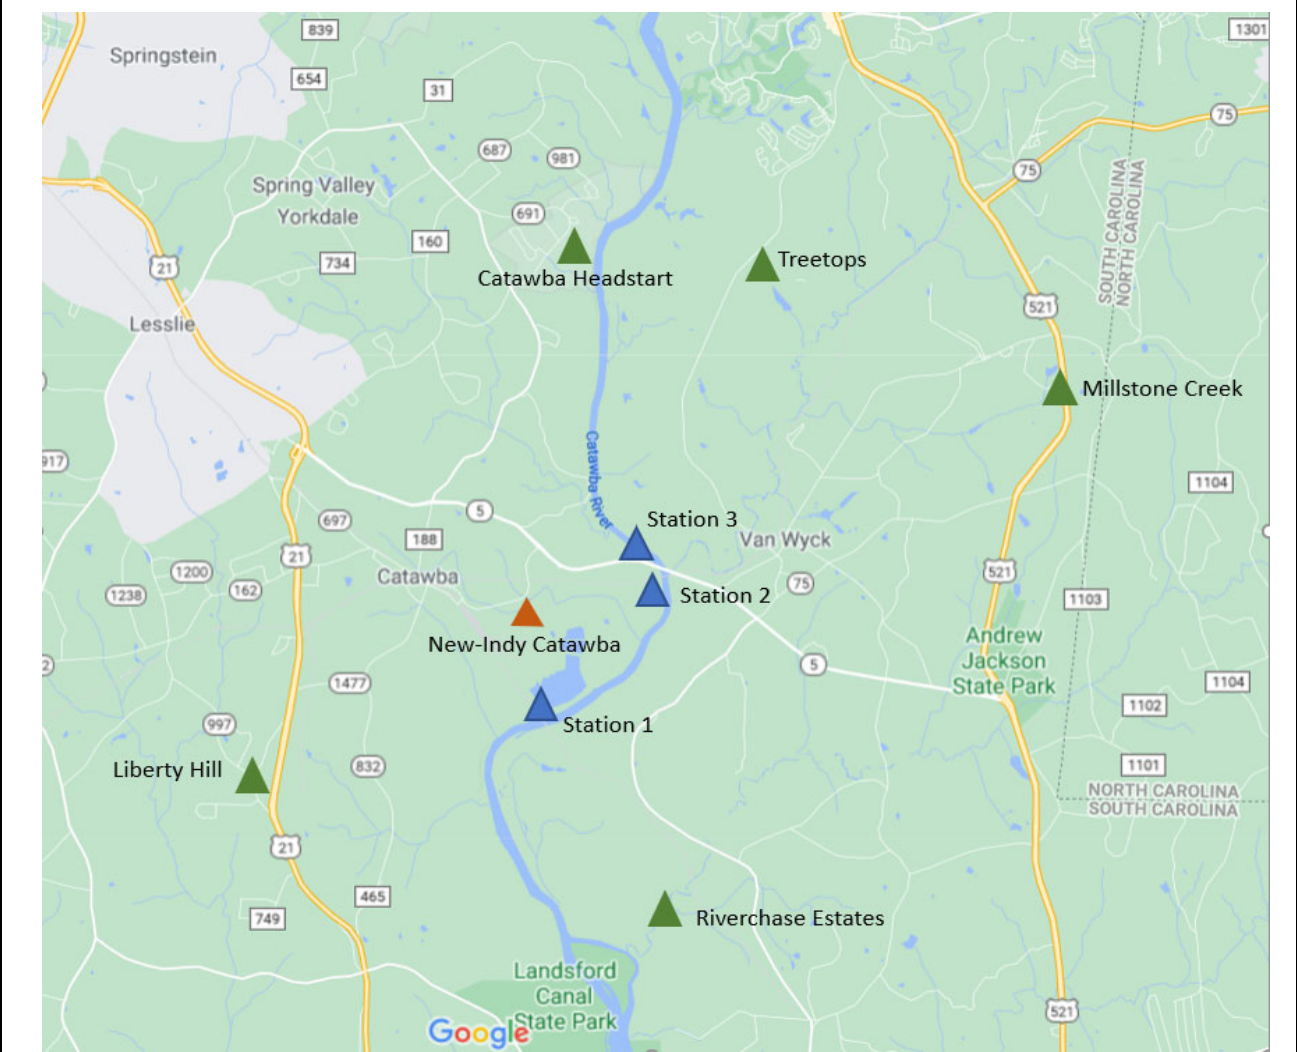
Wind rose – Shows the direction the wind is coming from, the monitoring station being at the center of the rose.

See wind rose diagram with aerial map figure for full wind data during this reporting period.

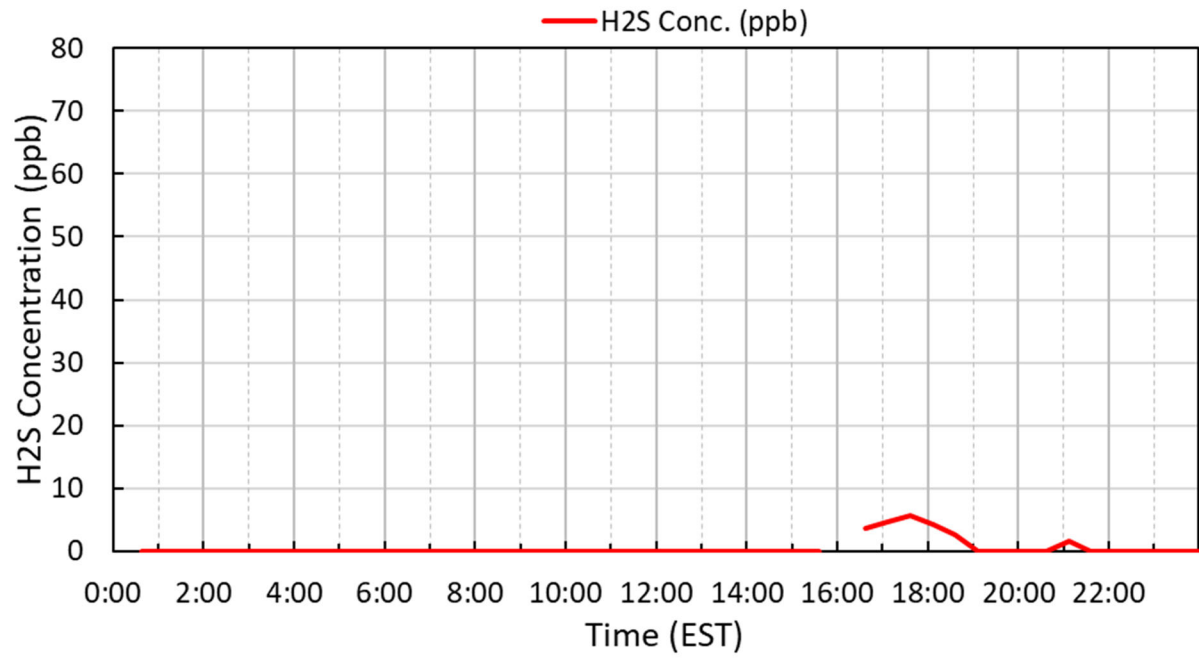
Treetops - 4/1/2022

Below are graphs for offsite locations where hydrogen sulfide (H₂S) was detected during the current reporting period.

| Instrument | Analyte | ATSDR MRL 14-day Avg Reached? | Concentration Range Detected ^a | 24-hr Average ^a | 7-day Average | ATSDR 14-day MRL |
|---|---|---|--|---|---|---|
| Acrulog PPB | H ₂ S | No | 0 – 6 ppb | 0.48 ppb ^b | 0.07 ppb | 70 ppb |

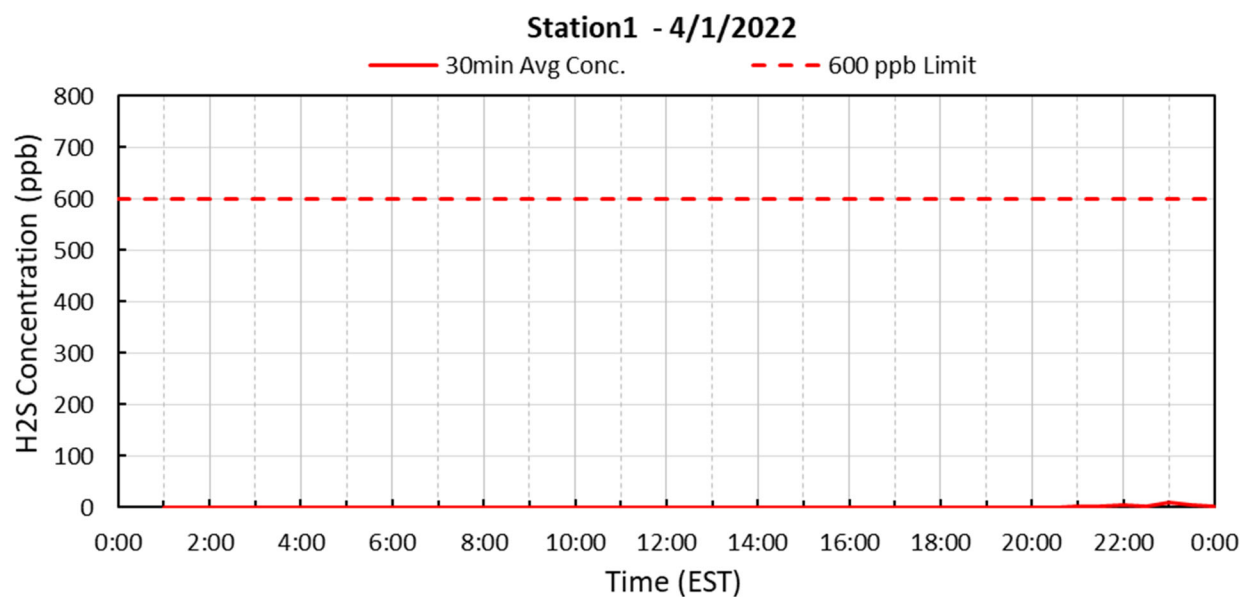
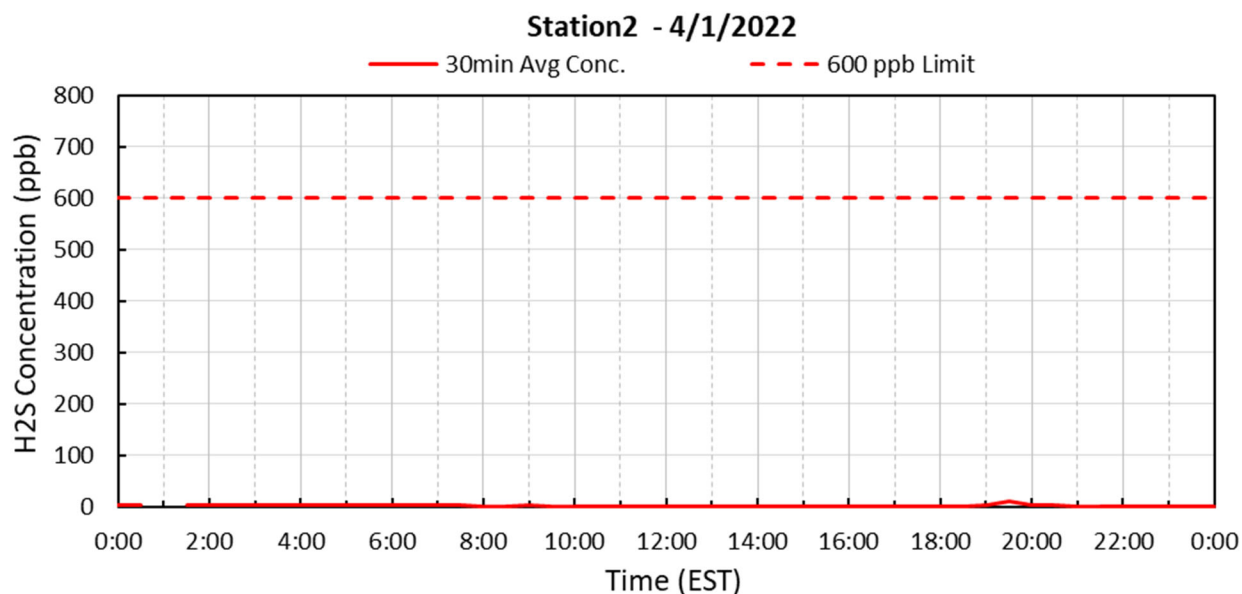
Below are graphs for onsite locations during the current reporting period.

Depending on wind direction, the H₂S measured at the onsite fence line locations may not exit mill property at reported concentrations. Wind directions from offsite locations, blowing onto mill property, will disperse ambient concentrations to lower levels prior to exiting the plant site.
