#### **Air Monitoring Summary Tables**

#### Period H<sub>2</sub>S Monitoring Hydrogen Sulfide Offsite Monitors

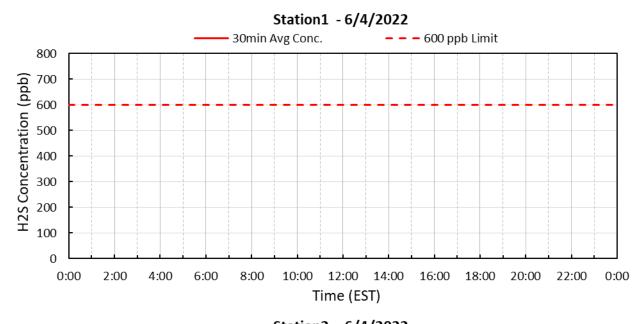
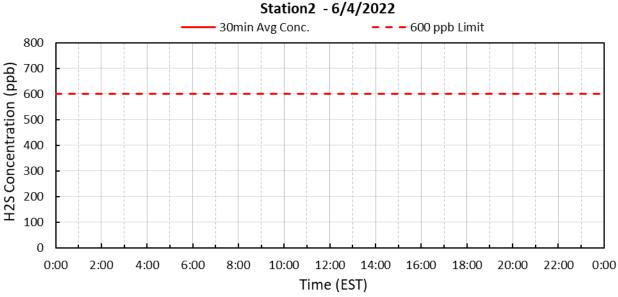
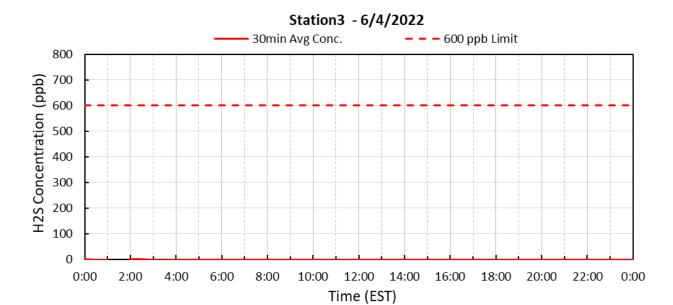
Below are graphs for onsite locations during the current reporting period.

Depending on wind direction, the H<sub>2</sub>S measured at the onsite fence line locations may not exit the mill property at reported concentrations. Wind directions from offsite locations, blowing onto mill property, will disperse ambient concentrations to lower levels prior to exiting the plant site.
