## **Air Monitoring Summary Tables**

### *From:* 6/17/22 12:00 am *To:* 6/17/22 11:59 pm

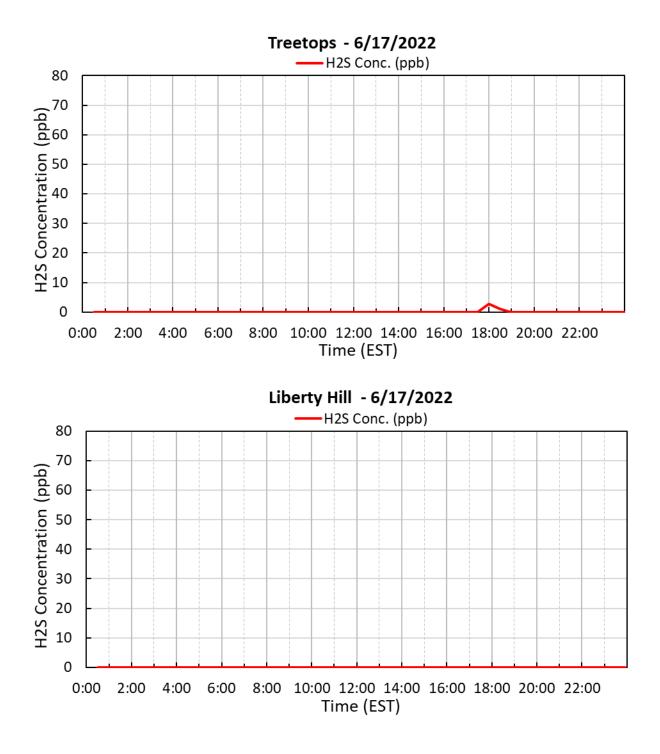
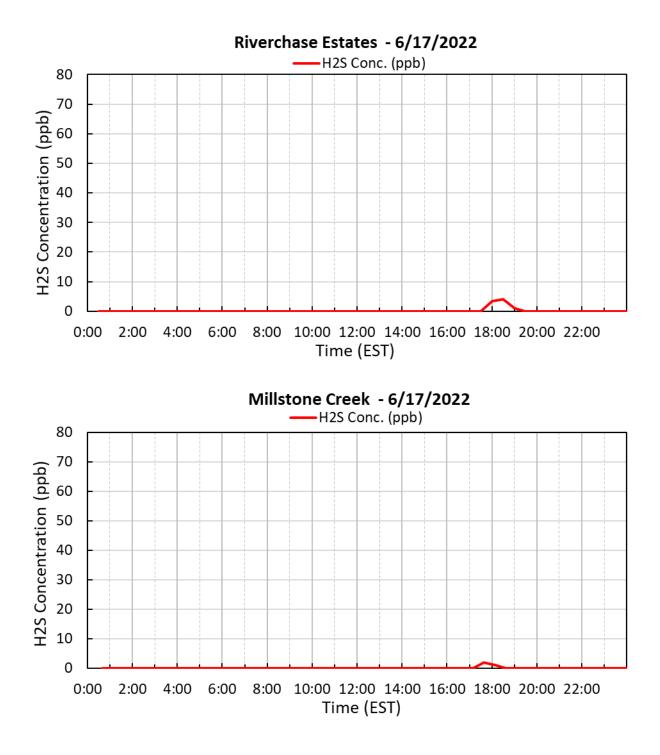
### Period H<sub>2</sub>S Monitoring Hydrogen Sulfide Offsite Monitors

Below are graphs for offsite locations where hydrogen sulfide  $(H_2S)$  was detected during the current reporting period.

The five stand-alone  $H_2S$  monitoring stations correlate with five previous EPA's Viper monitoring system which includes areas to the north-northeast and south-southwest of the New-Indy Catawba Mill.

Winds were mostly coming from the west-southwest at 2 to 24 mph.

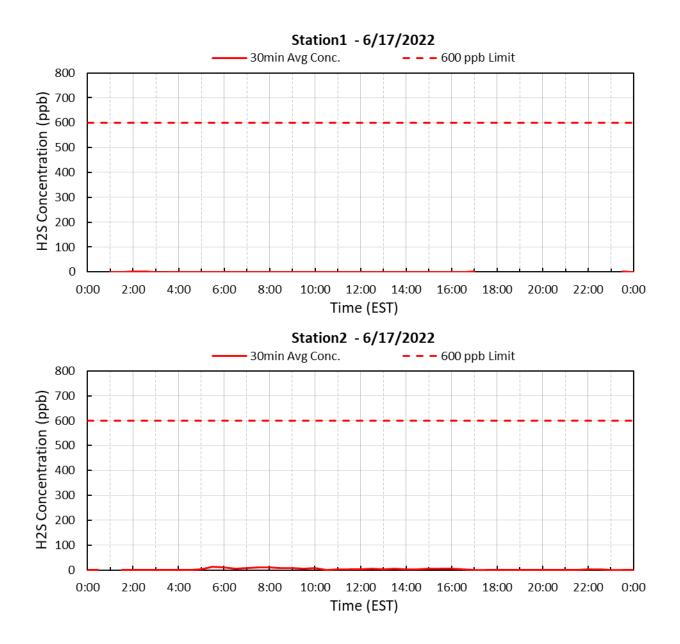
### Period H<sub>2</sub>S Monitoring Hydrogen Sulfide Onsite Monitors

Below are graphs for onsite locations during the current reporting period.

Depending on wind direction, the  $H_2S$  measured at the onsite fence line locations may not exit the mill property at reported concentrations. Wind directions from offsite locations, blowing onto mill property, will disperse ambient concentrations to lower levels prior to exiting the plant site.

Winds were mostly coming from the west-southwest at 2 to 24 mph.
