Air Monitoring Summary Tables

From: 6/29/22 12:00 am *To:* 6/29/22 11:59 pm

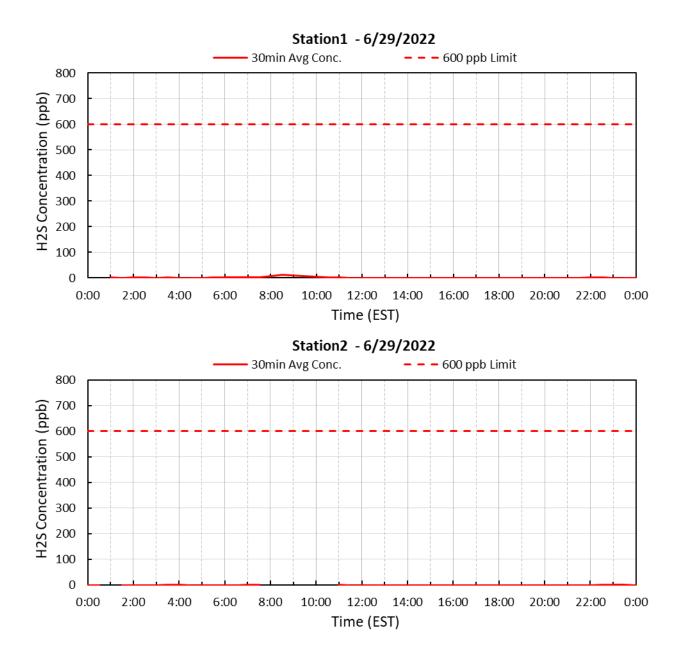
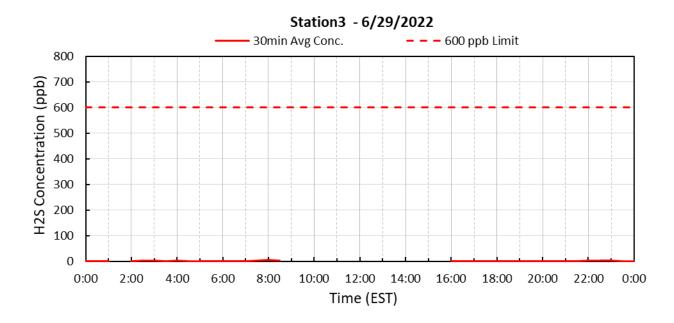
Below are graphs for onsite locations during the current reporting period.

Depending on wind direction, the H_2S measured at the onsite fence line locations may not exit the mill property at reported concentrations. Wind directions from offsite locations, blowing onto mill property, will disperse ambient concentrations to lower levels prior to exiting the plant site.
