# **Air Monitoring Summary Tables**

### *From:* 7/07/22 12:00 am *To:* 7/07/22

## Period H<sub>2</sub>S Monitoring Hydrogen Sulfide Offsite Monitors

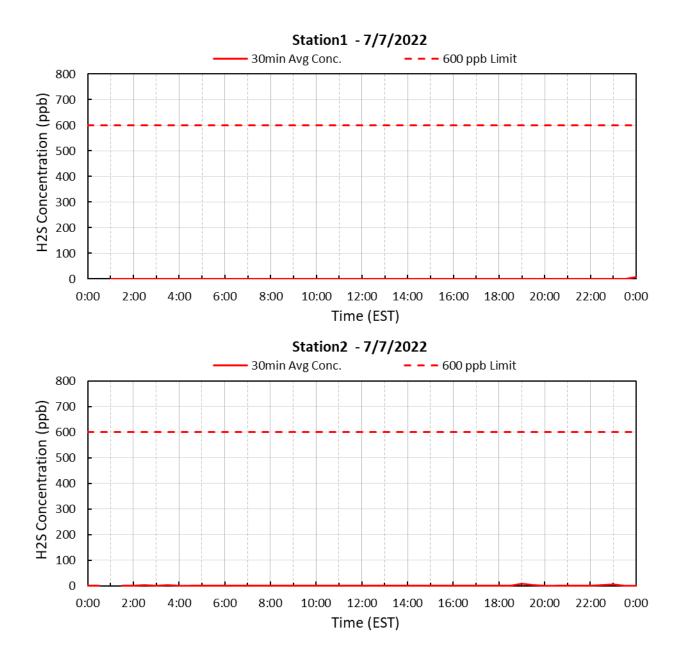
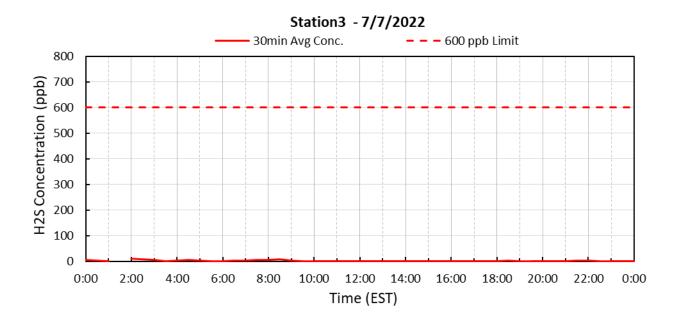
Below are graphs for onsite locations during the current reporting period.

Depending on wind direction, the  $H_2S$  measured at the onsite fence line locations may not exit the mill property at reported concentrations. Wind directions from offsite locations, blowing onto mill property, will disperse ambient concentrations to lower levels prior to exiting the plant site.

Winds were mostly coming from the south-southwest direction at 1 to 8 mph.
