# **Air Monitoring Summary Tables**

From: 10/12/22 12:00 am To: 10/12/22 11:59 pm

### Period H<sub>2</sub>S Monitoring Hydrogen Sulfide Offsite Monitors

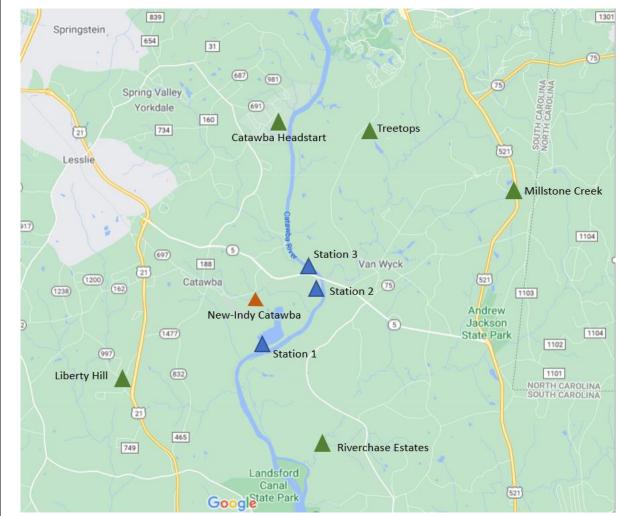
Station 1 Wind Rose – Shows the direction the wind is coming from, the monitoring station being at the center of the rose.

See wind rose diagram with aerial map figure for full wind data during this reporting period.

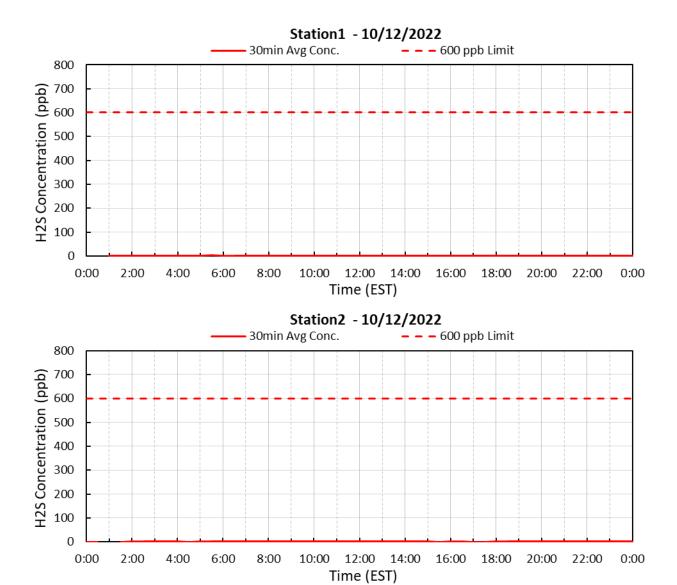
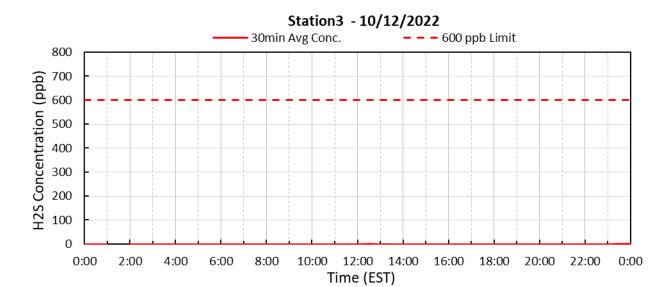
Below are graphs for onsite locations during the current reporting period.

Depending on wind direction, the H<sub>2</sub>S measured at the onsite fence line locations may not exit the mill property at reported concentrations. Wind directions from offsite locations, blowing onto mill property, will disperse ambient concentrations to lower levels prior to exiting the plant site.
