Air Monitoring Summary Tables

New-Indy Catawba

Period H₂S Monitoring Hydrogen Sulfide Offsite Monitors

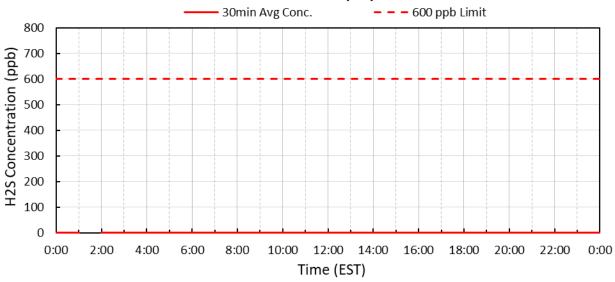
Station3 - 10/24/2022

Below are graphs for onsite locations during the current reporting period.

Depending on wind direction, the H₂S measured at the onsite fence line locations may not exit the mill property at reported concentrations. Wind directions from offsite locations, blowing onto mill property, will disperse ambient concentrations to lower levels prior to exiting the plant site.
