# **Air Monitoring Summary Tables**

## Period H<sub>2</sub>S Monitoring Hydrogen Sulfide Offsite Monitors

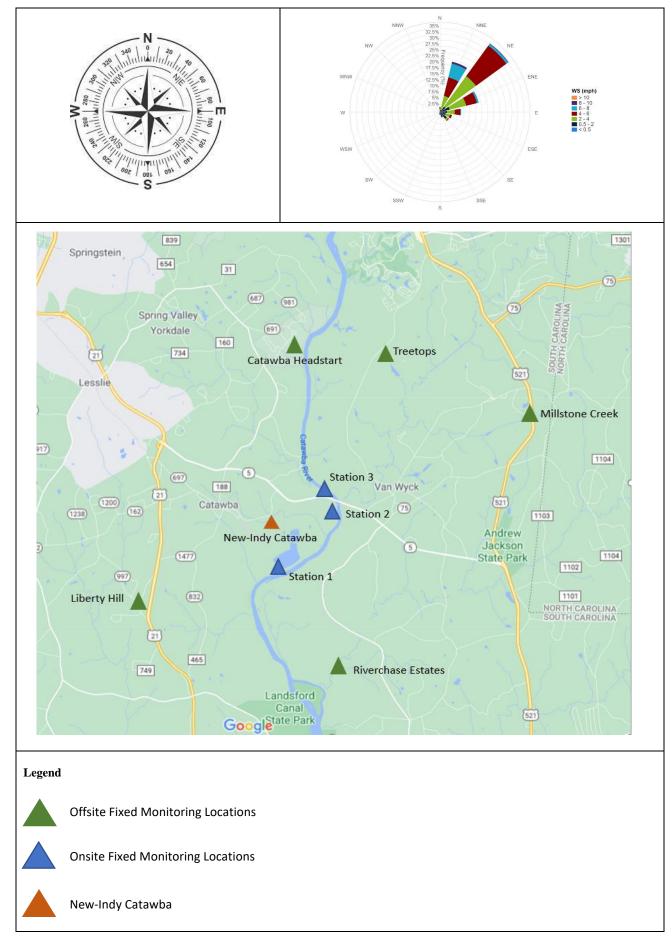
Station 1 Wind Rose – Shows the direction the wind is coming from, the monitoring station being at the center of the rose.

Winds were coming from the north-northeast, northeast, and east-northeast direction at 1 to 8 mph.

See wind rose diagram with aerial map figure for full wind data during this reporting period.

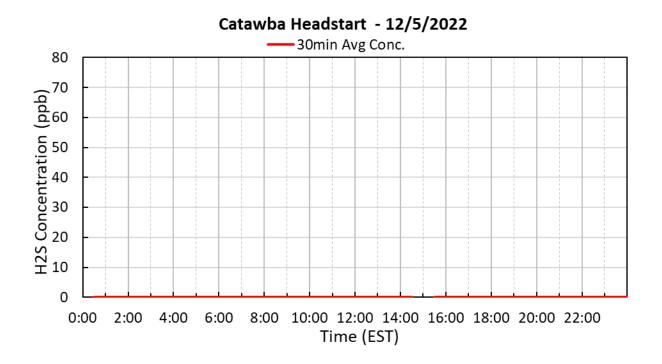
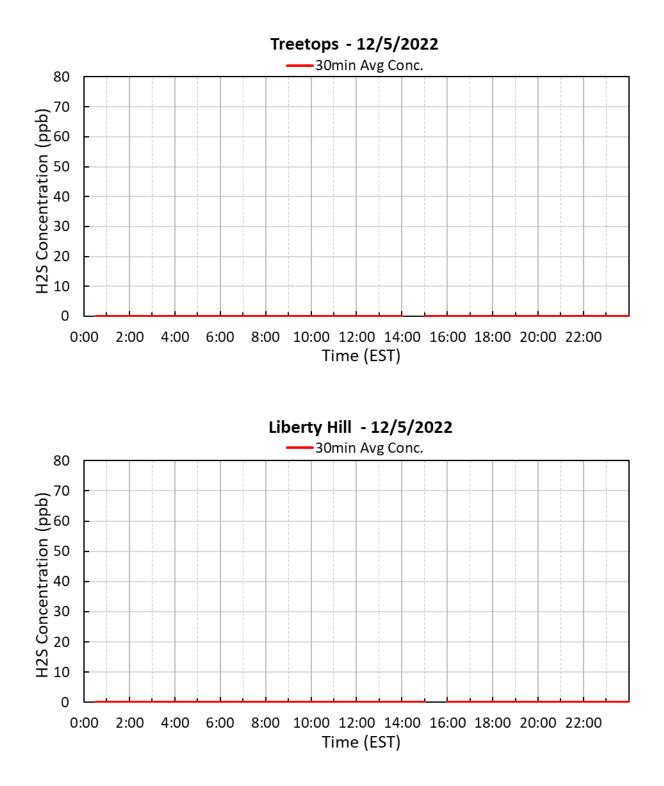
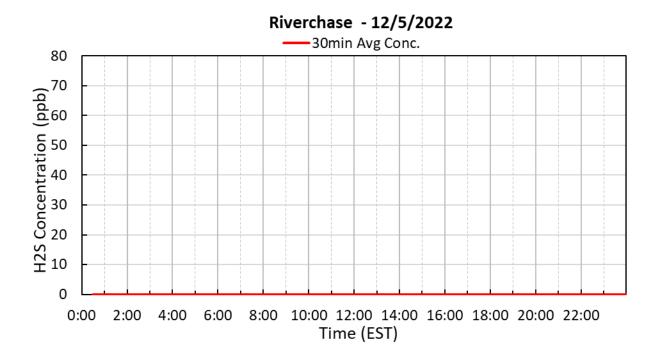
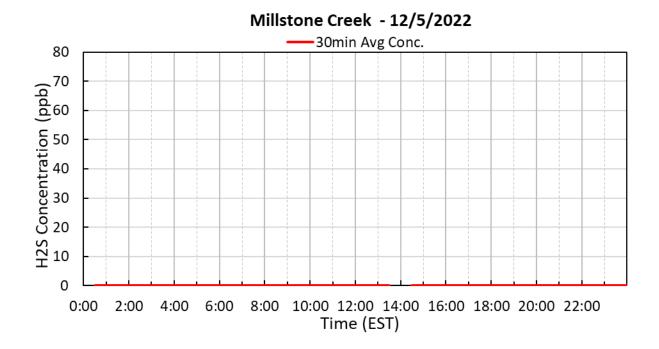
Below are graphs for offsite locations where hydrogen sulfide  $(H_2S)$  was detected during the current reporting period.

The five stand-alone  $H_2S$  monitoring stations correlate with five previous EPA's Viper monitoring system which includes areas to the north-northeast and south-southwest of the New-Indy Catawba Mill.

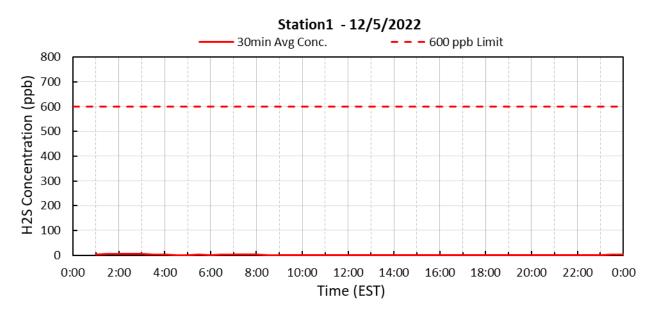
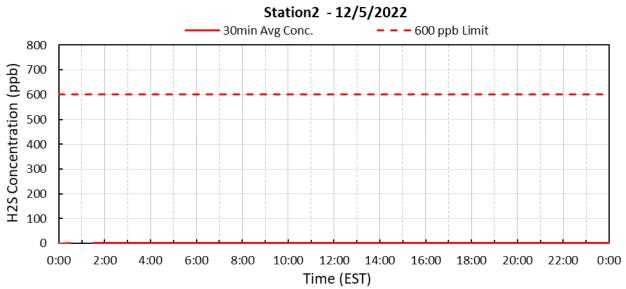
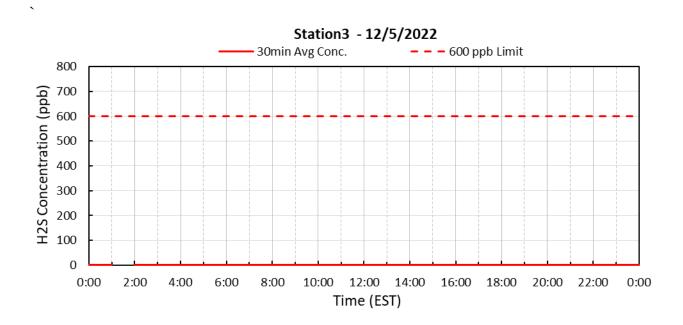
Below are graphs for onsite locations during the current reporting period.

Depending on wind direction, the  $H_2S$  measured at the onsite fence line locations may not exit the mill property at reported concentrations. Wind directions from offsite locations, blowing onto mill property, will disperse ambient concentrations to lower levels prior to exiting the plant site.
