# **Air Monitoring Summary Tables**

### *From:* 12/07/22 12:00 am

#### 12/07/22 11:59 pm

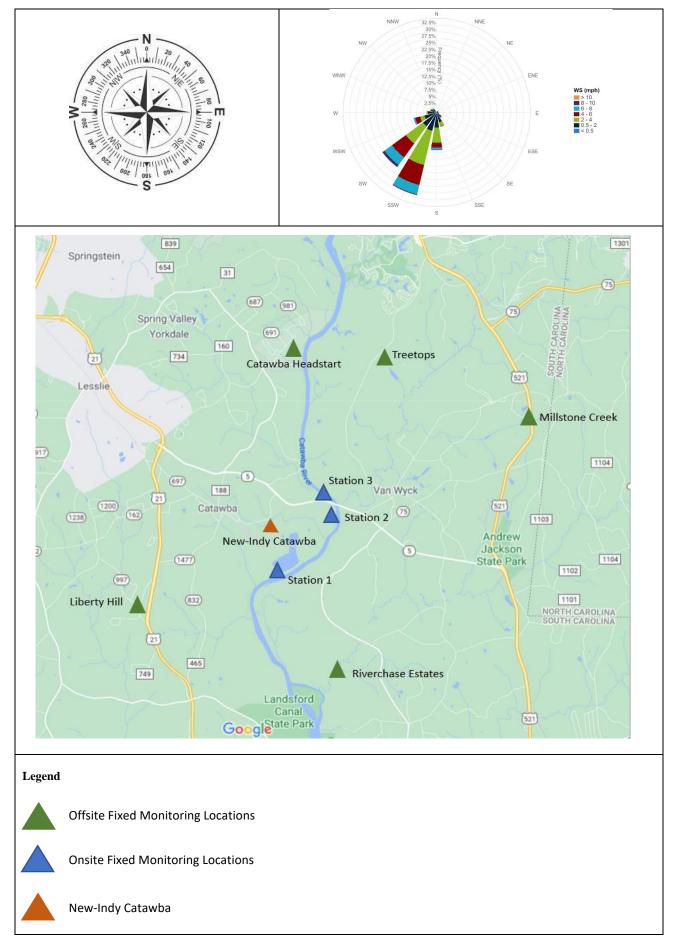
Station 1 Wind Rose – Shows the direction the wind is coming from, the monitoring station being at the center of the rose.

See wind rose diagram with aerial map figure for full wind data during this reporting period.

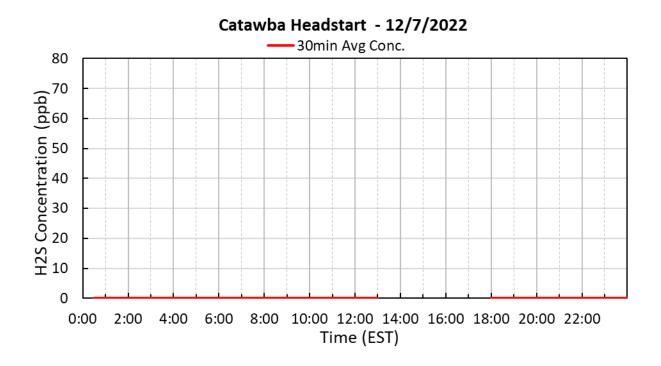
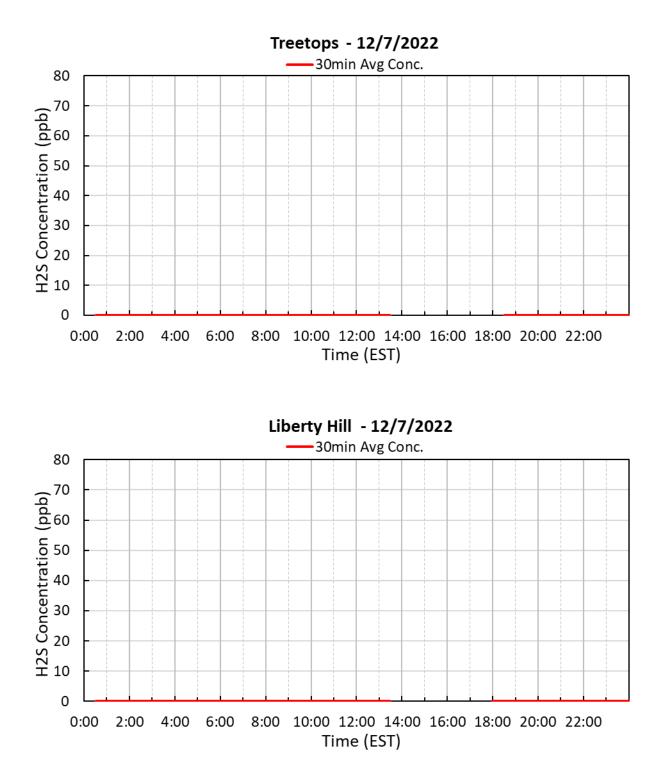
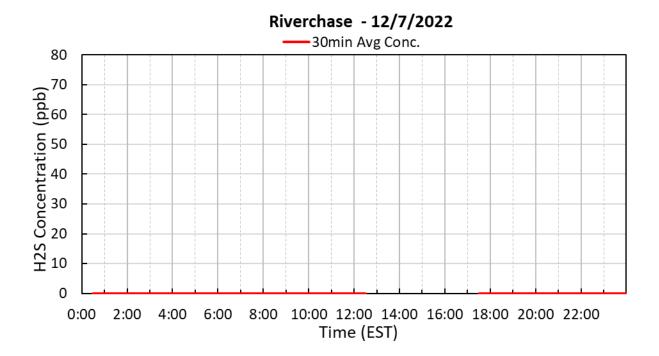
## Period H<sub>2</sub>S Monitoring Hydrogen Sulfide Offsite Monitors

Below are graphs for offsite locations where hydrogen sulfide  $(H_2S)$  was detected during the current reporting period.

The five stand-alone  $H_2S$  monitoring stations correlate with five previous EPA's Viper monitoring system which includes areas to the north-northeast and south-southwest of the New-Indy Catawba Mill.

Winds were coming from the south, south-southwest, west, and west-southwest at 1 to 6 mph.

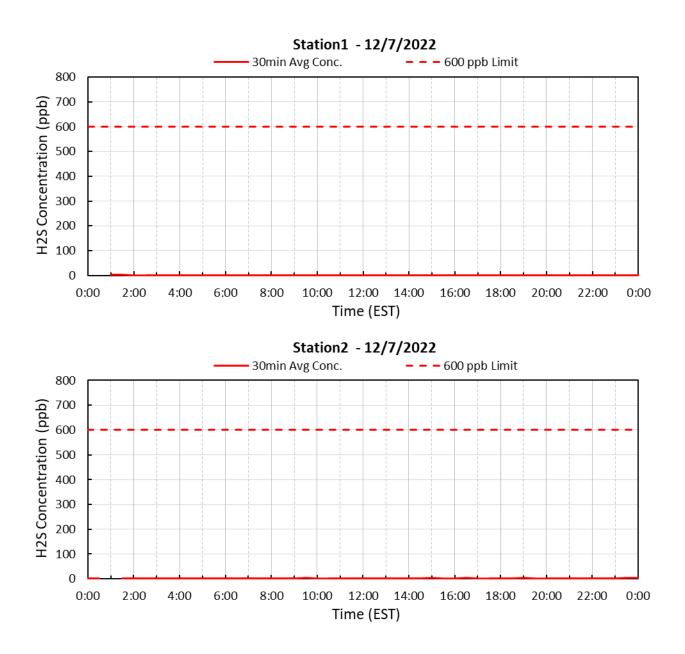
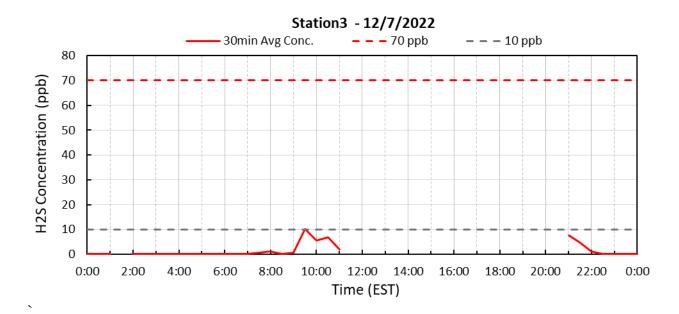
## Period H<sub>2</sub>S Monitoring Hydrogen Sulfide Onsite Monitors

Below are graphs for onsite locations during the current reporting period.

Depending on wind direction, the  $H_2S$  measured at the onsite fence line locations may not exit the mill property at reported concentrations. Wind directions from offsite locations, blowing onto mill property, will disperse ambient concentrations to lower levels prior to exiting the plant site.

Winds were coming from the south, south-southwest, west, and west-southwest at 1 to 6 mph
